KYTC's First Bat Bridge Project

Restore | Renew | Replace

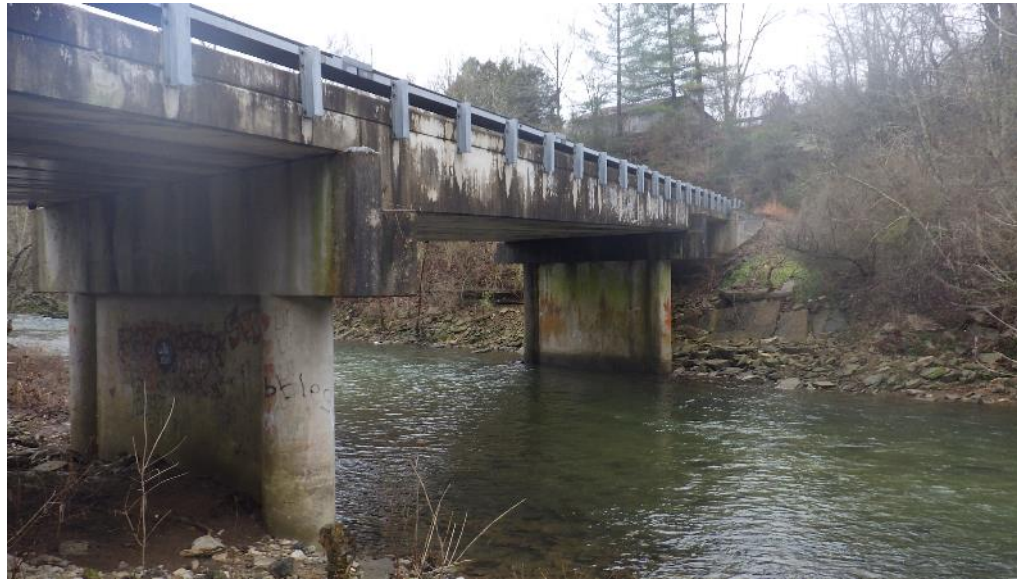
- Required complete deck and super-structure replacement (27 beams)

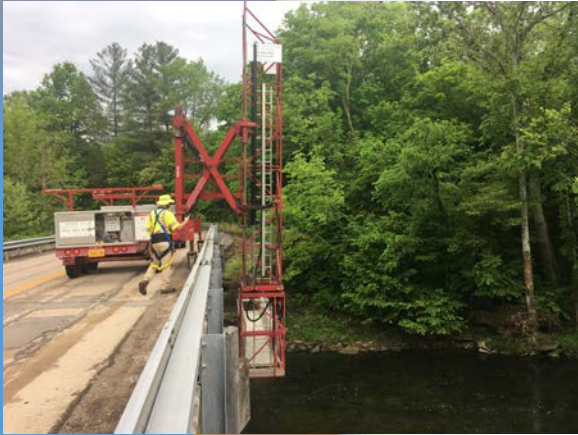
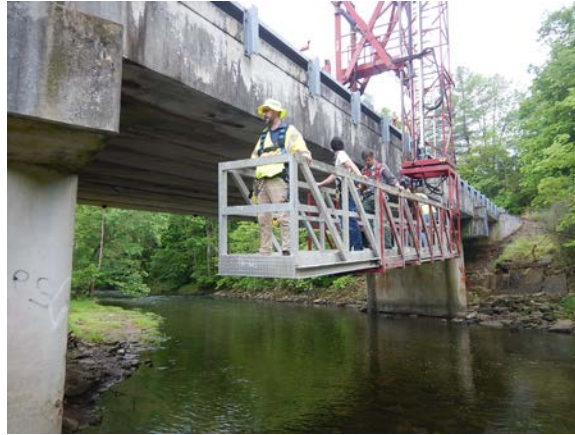
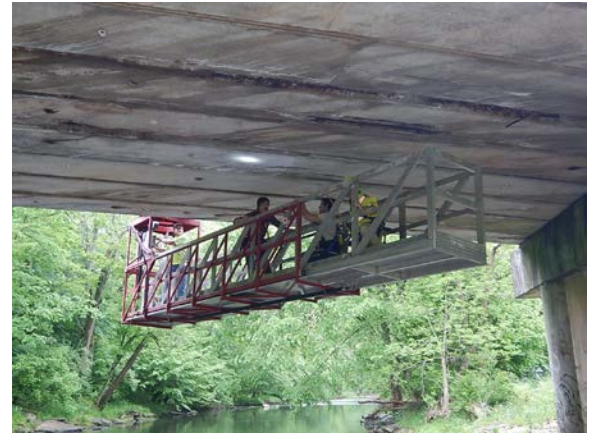
Platform Survey 2019

Performed by USFWS, KYTC, and Eco-Tech (now ICF) on May 10, 2019

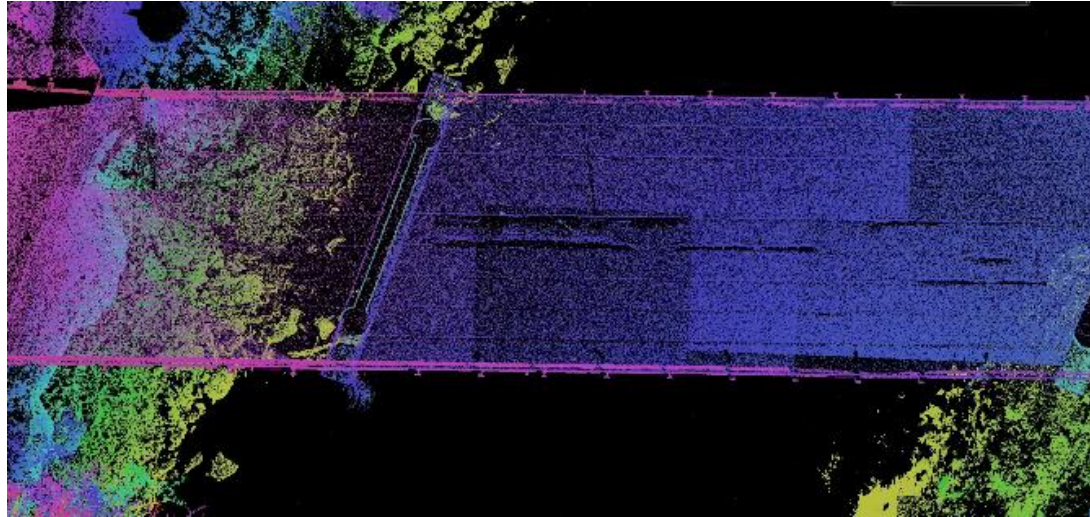
A Closer Look

LiDAR and field measurements estimated that the existing bridge had ~572 linear ft of gaps greater than ½” width and 133 cubic ft of potential roosting area.

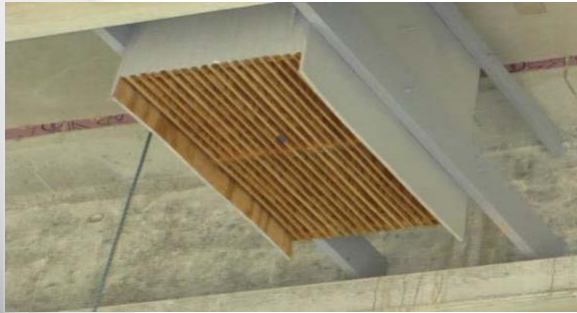
Roost Habitats

Bat Boxes are typically made of wood and will be a future maintenance issue. Potential to be damaged by vandals.

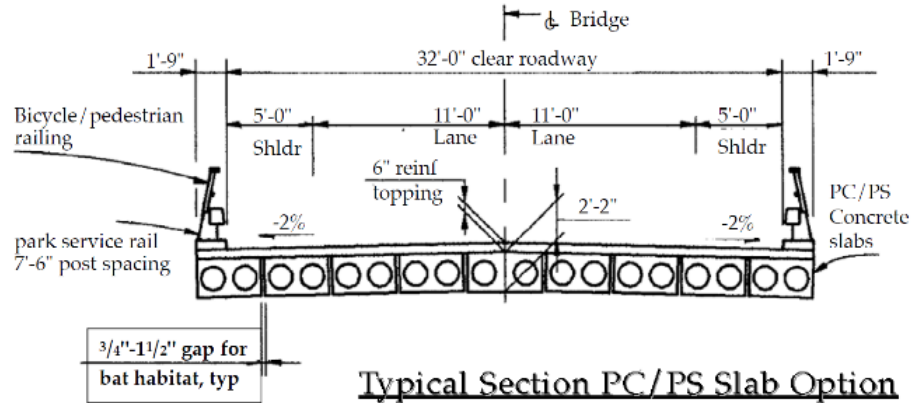
“Oregon Superstructure”

Structural options to provide bat friendly habitat.

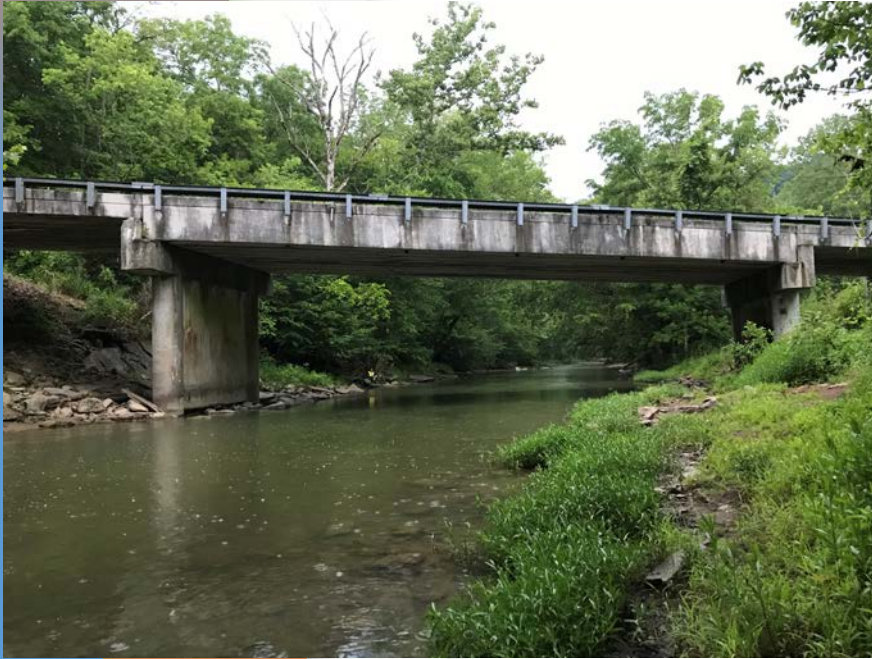
Pre-Construction Monitoring

Emergence Counts for Baseline Data

Date (2020)	Night 1	Night 2
June 18-19	754	643
July 23-24	1002	912
August 17-19	839	496

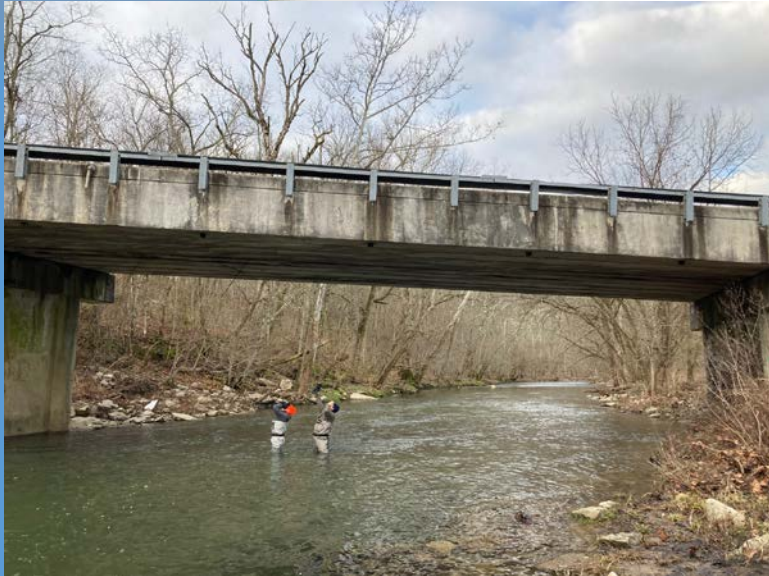
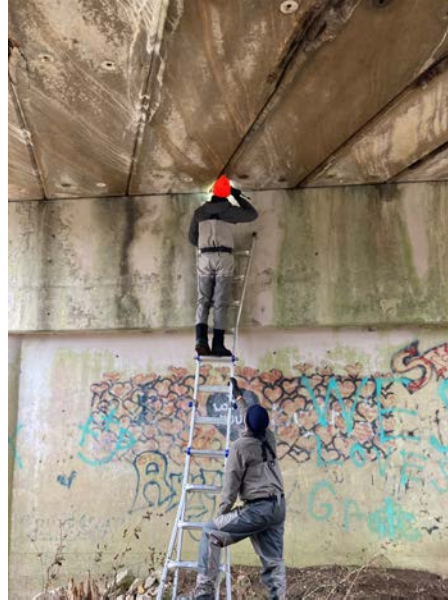
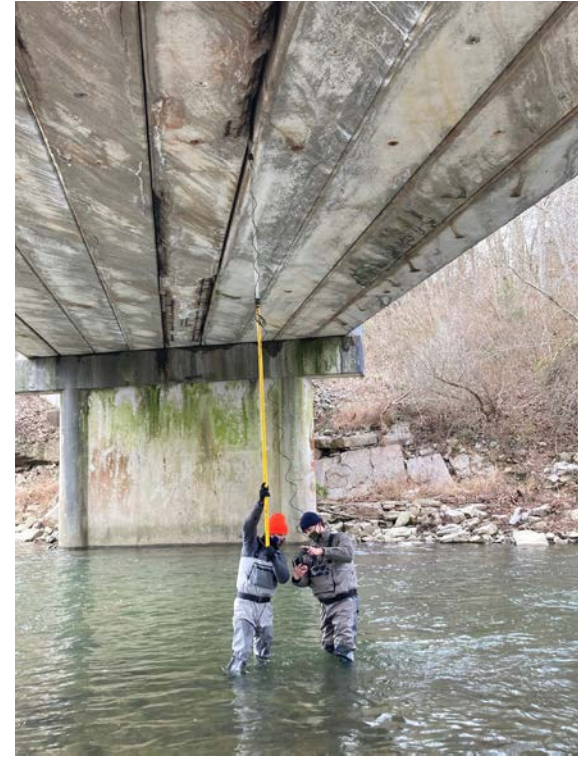
- ❑ Preconstruction spot check performed on January 7, 2021
- ❑ Entire structure was inspected for potential roosting individuals
- ❑ Gave contractors the green light for construction

Performed by Drew Powell and Triston Mullins

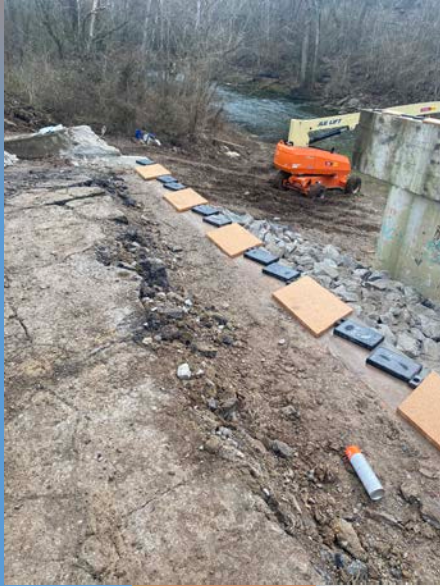
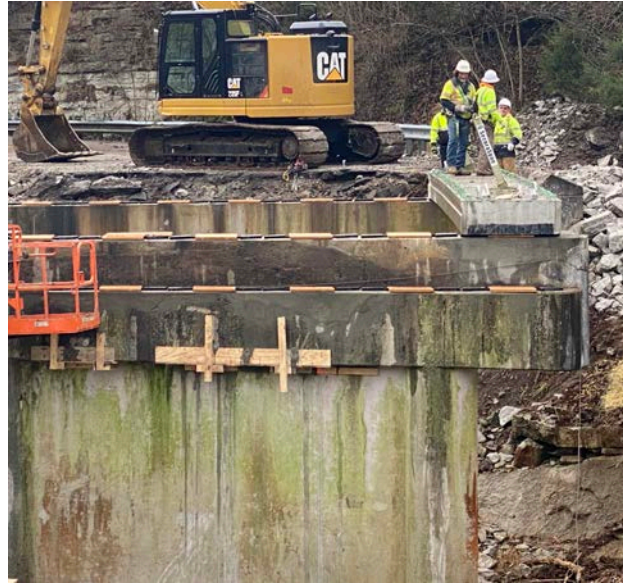
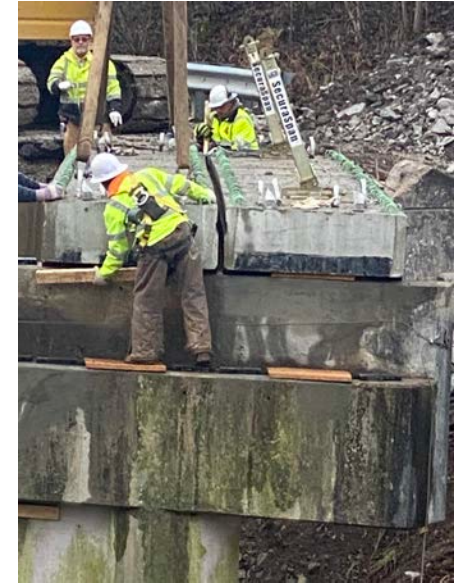
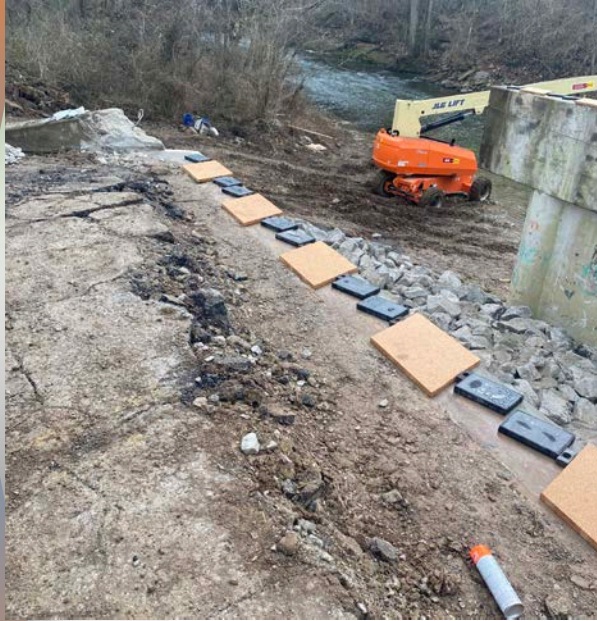
Construction completed on March 15, 2021

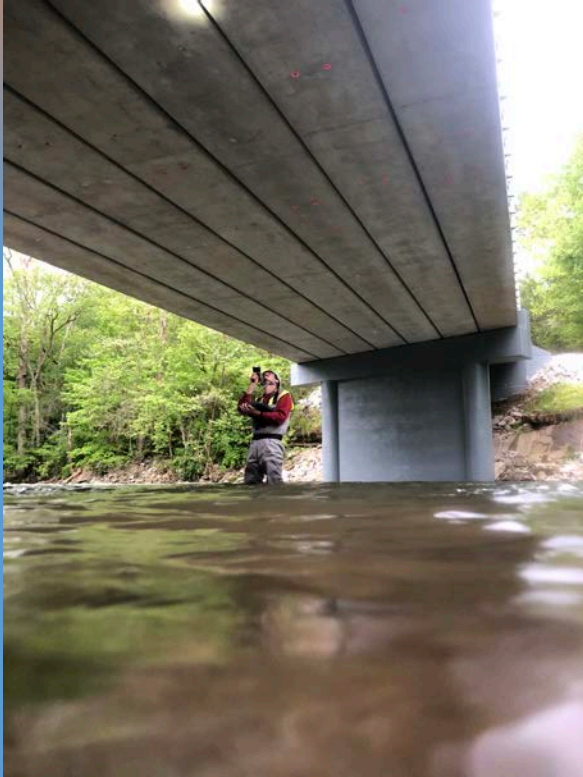
Post Construction Monitoring

Emergence Counts for Year 1 Data		
Date (2021)	Night 1	Night 2
May 6-7	295	250
June 2-3	372	234
August 12 (Platform)	1,143 (18 EPFU, 1,125 MYGR)

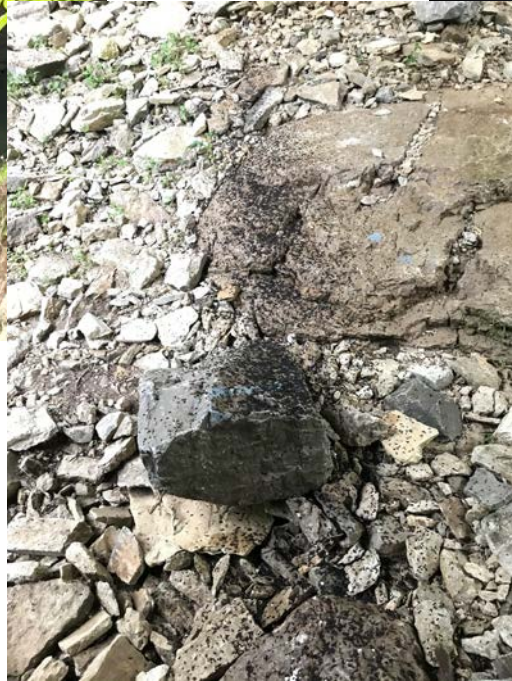
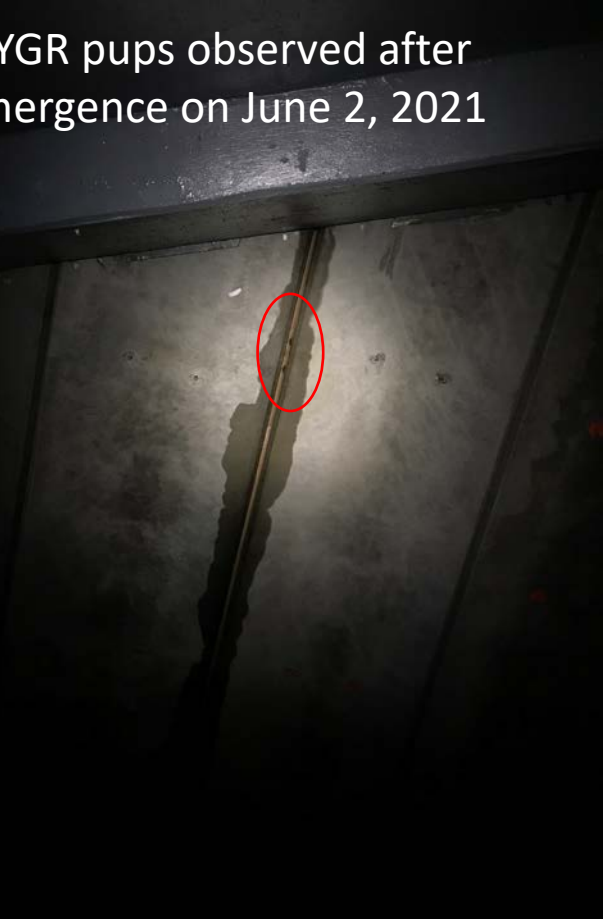
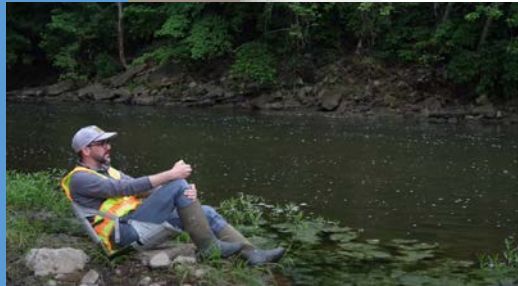
MYGR pups observed after emergence on June 2, 2021

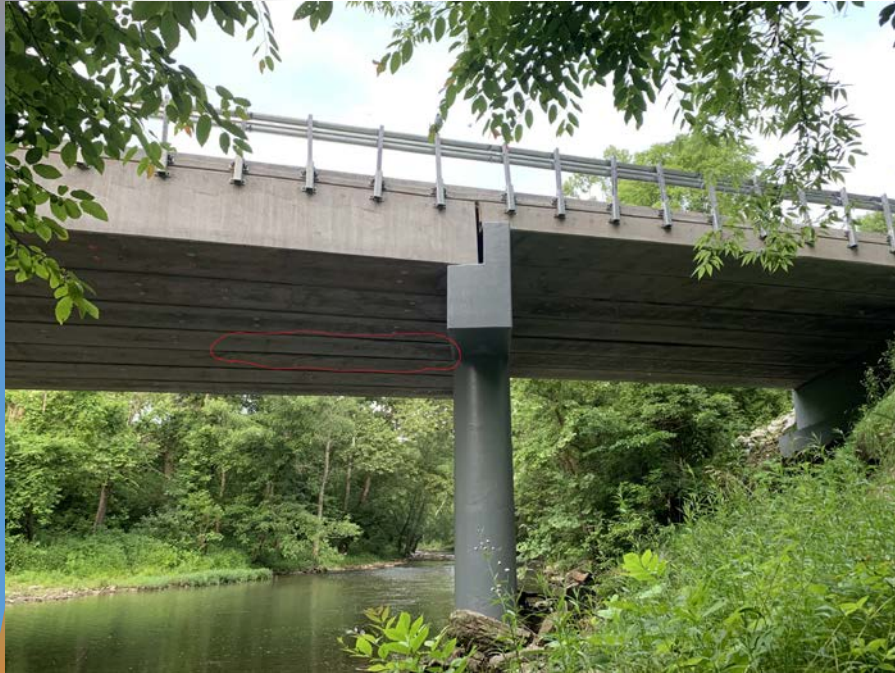
Year 2 Monitoring

Emergence Counts for Year 2 Data		
Date (2022)	Night 1	Night 2
May 2,4	50	48
June 13-14	1700!	1600!
August 16-17	1,248	1,206
