**NATIONAL
TRANSPORTATION
IN INDIAN COUNTRY
CONFERENCE**

Bridge 101

Dale C. Heglund, PE/PLS

UPPER GREAT PLAINS
TRANSPORTATION INSTITUTE
NORTH DAKOTA LOCAL TECHNICAL ASSISTANCE PROGRAM

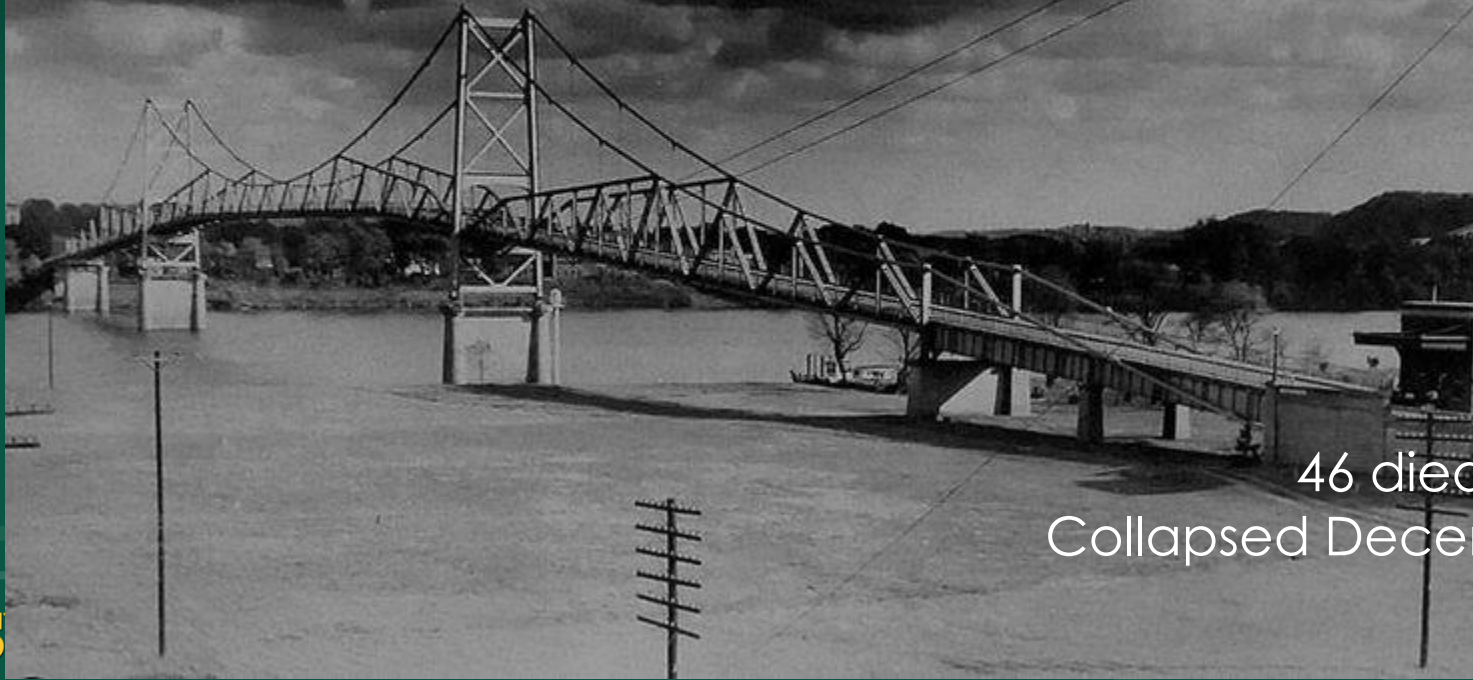
The Silver Bridge was an eyebar-chain suspension bridge built in 1928. The bridge carried US 35 over the Ohio River, connecting West Virginia and Ohio.

46 died
Collapsed December 1967

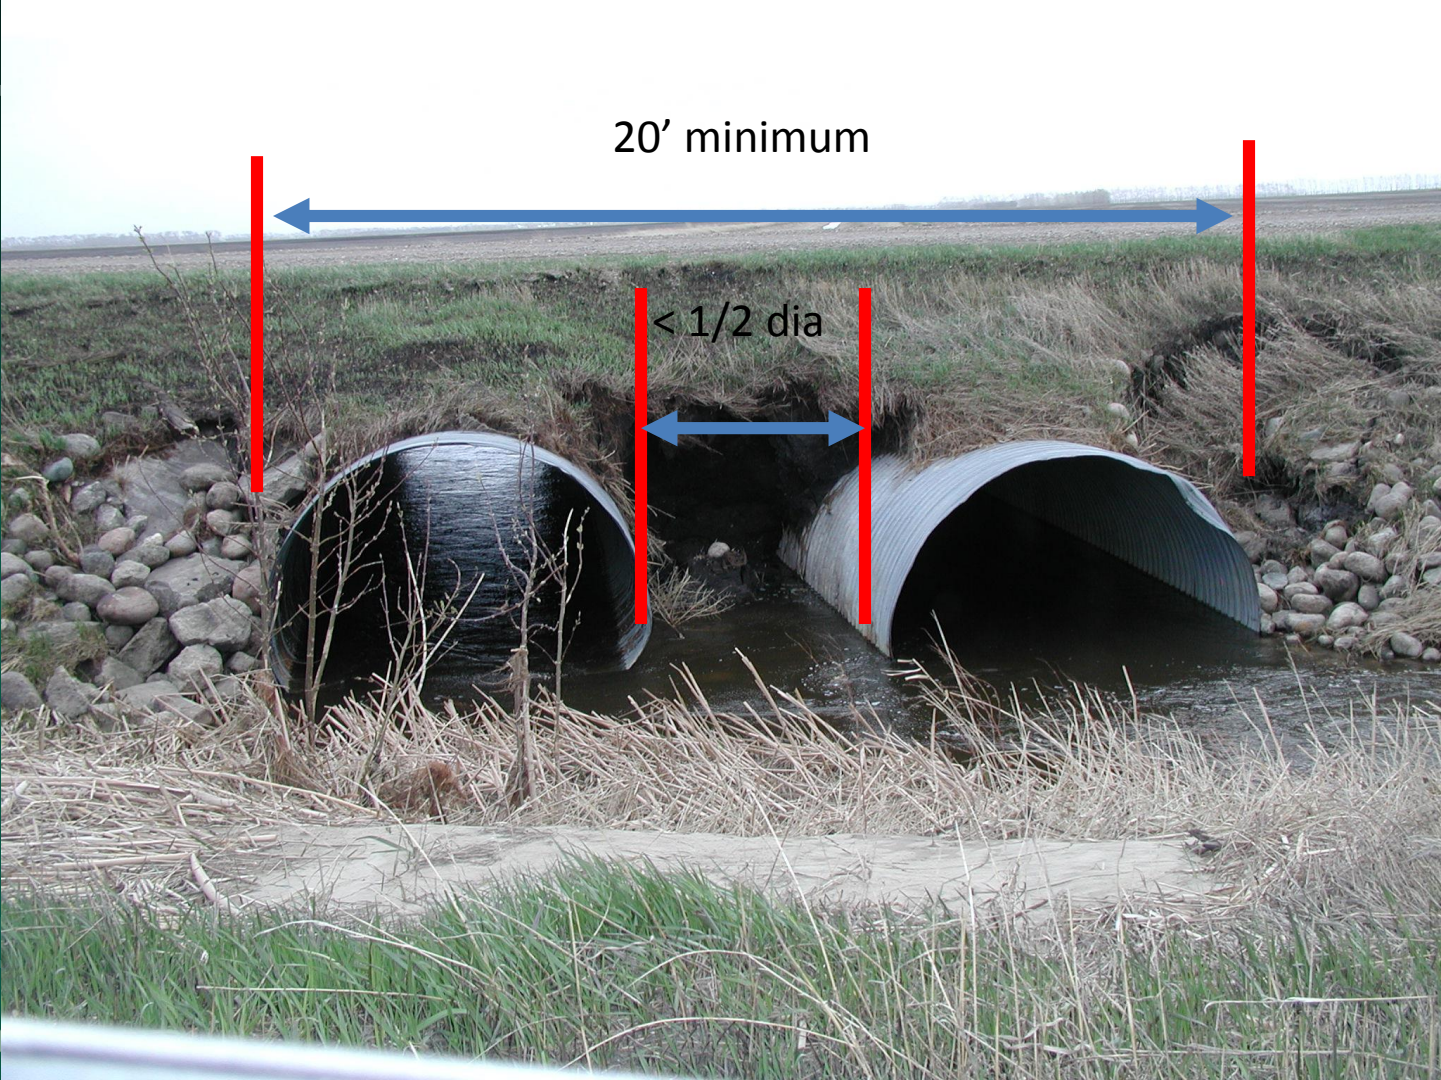
Bridge length
20' minimum

20' minimum

< 1/2 dia

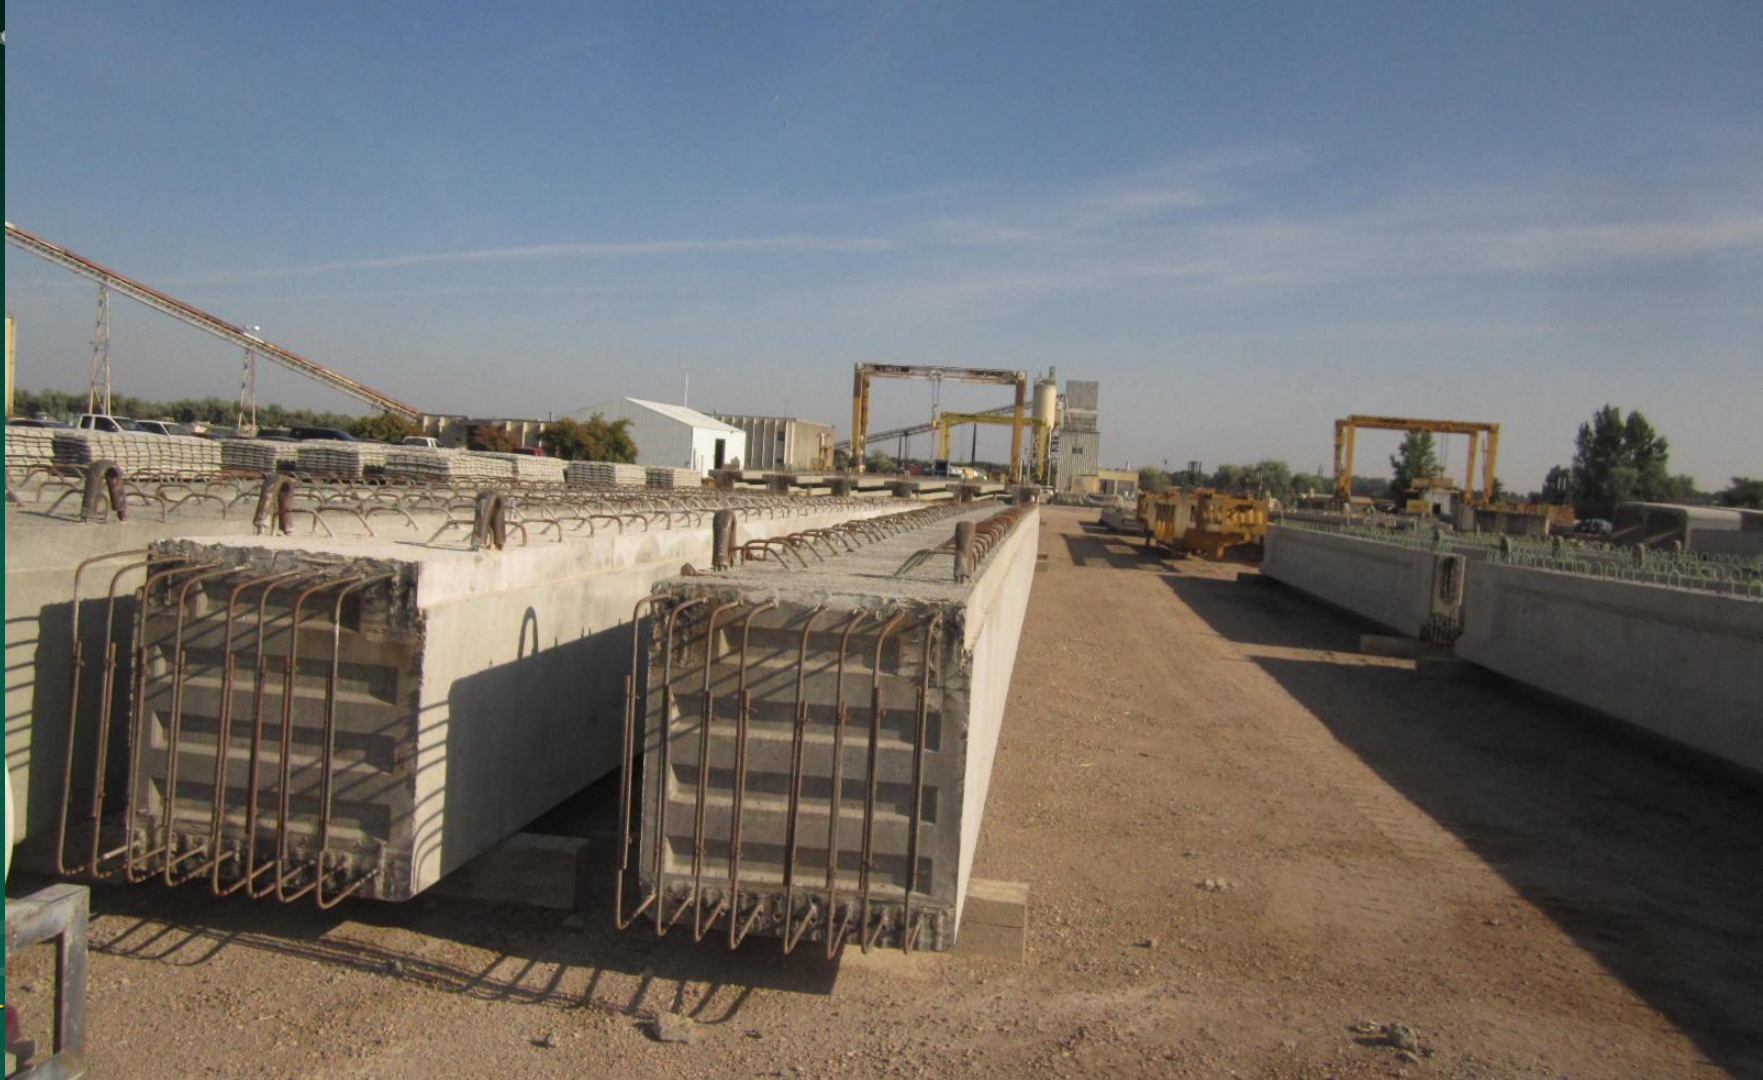
Beam Shapes

W or H – S or I Shaped

Wide Flange
W or H Beam

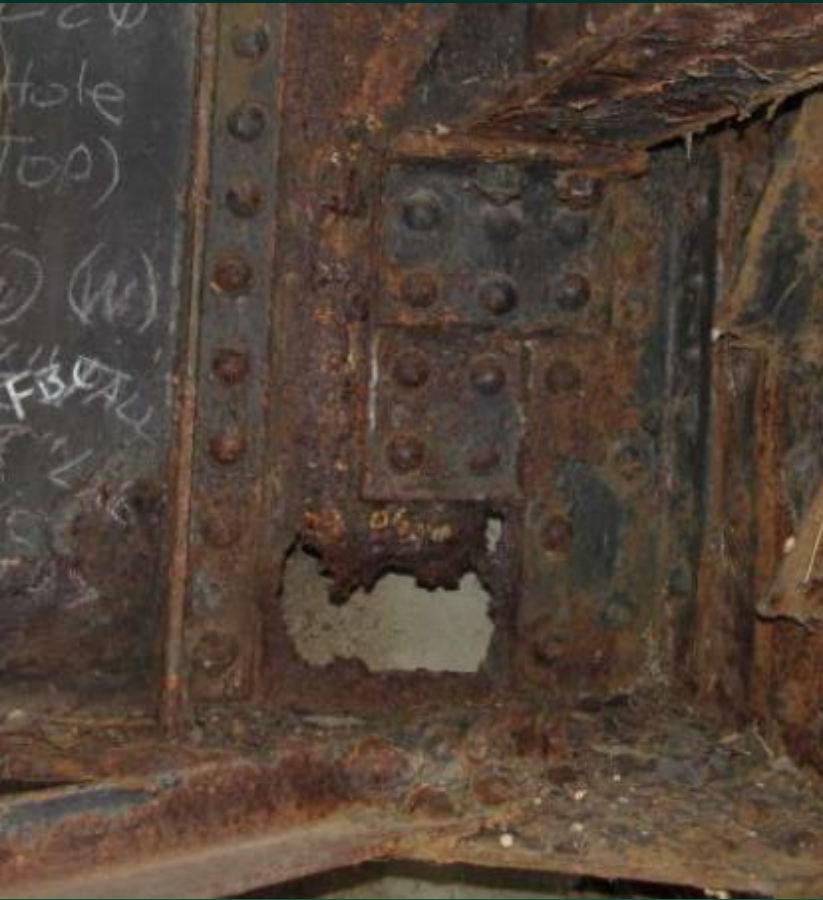
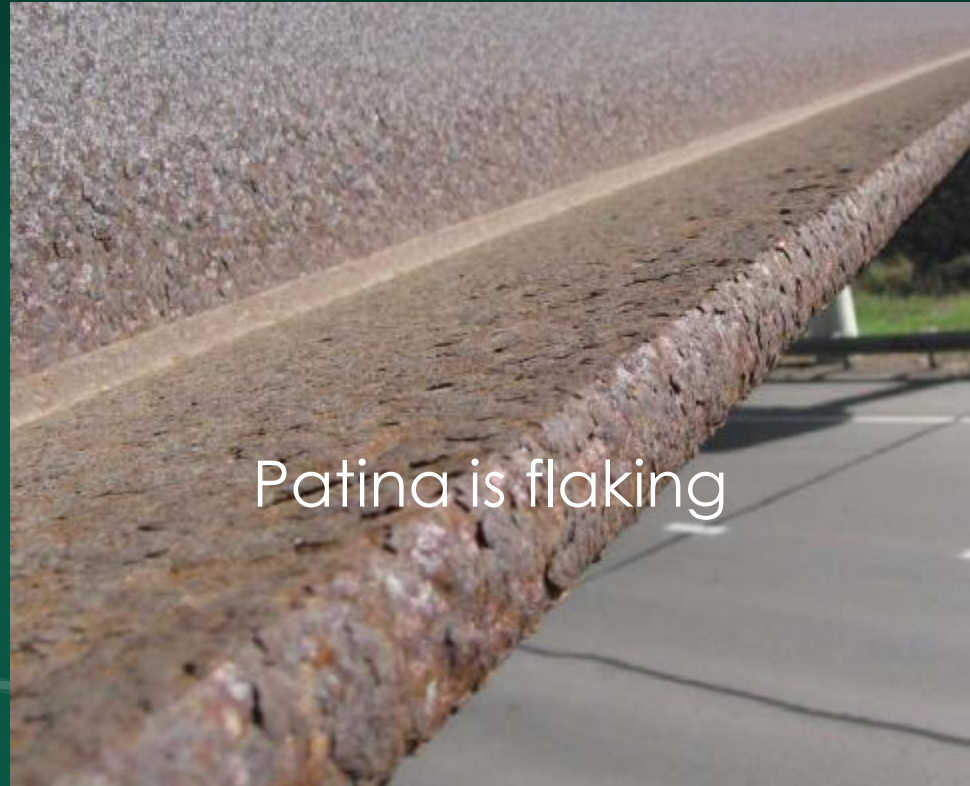
Steel and Weathering Steel

Patina is flaking

Pack Rust Expansion 7X

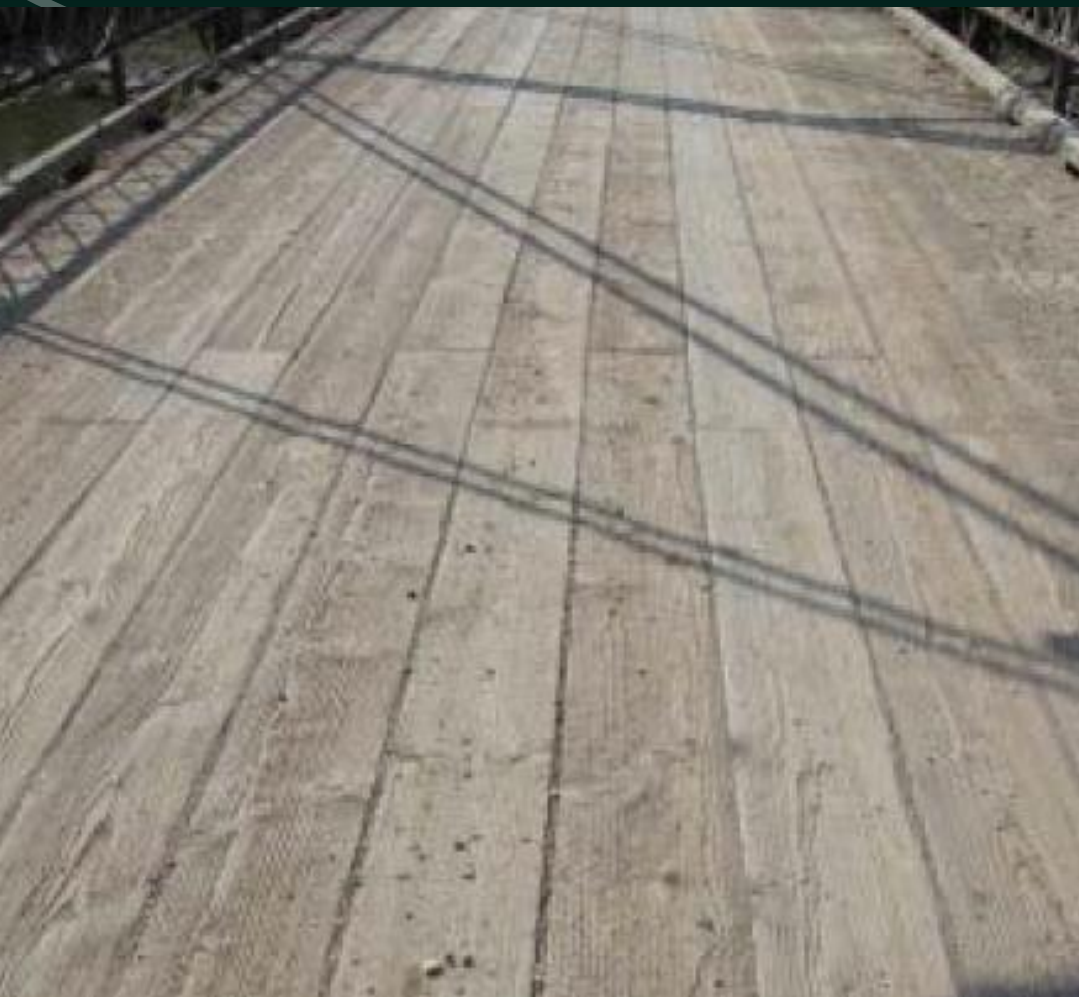
Look for
damage
and gaps

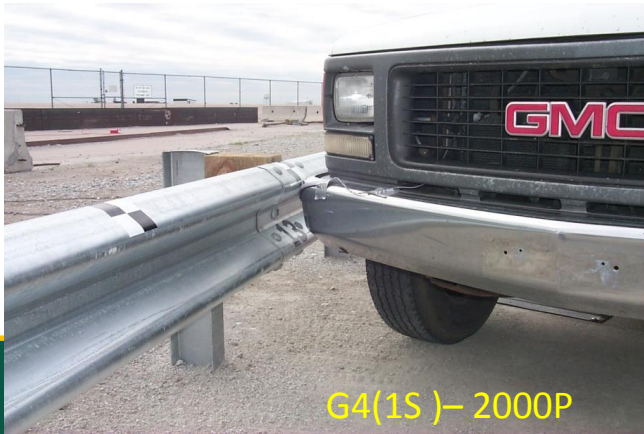
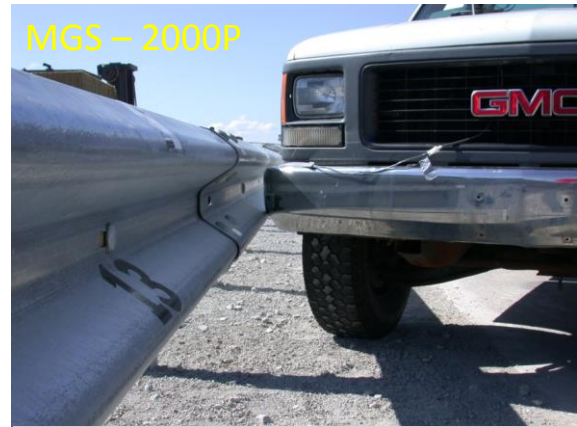
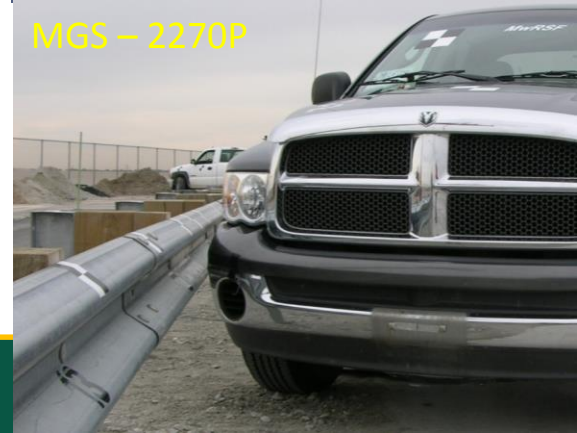
Increased Rail Height

- Improved capture
- Reduced rollover potential

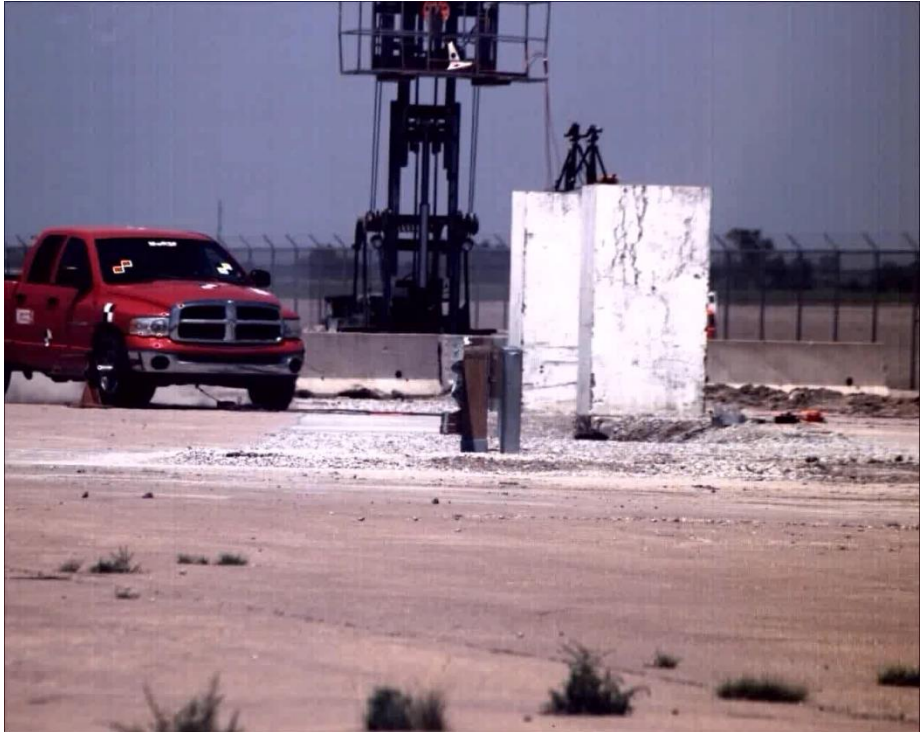
Test No. MGSBR-1

- MASH
 - 3-11
 - 2270P
- Impact conditions
 - 61.9 mph
 - 24.9 deg.
- Dynamic deflection
 - 48.9 in.

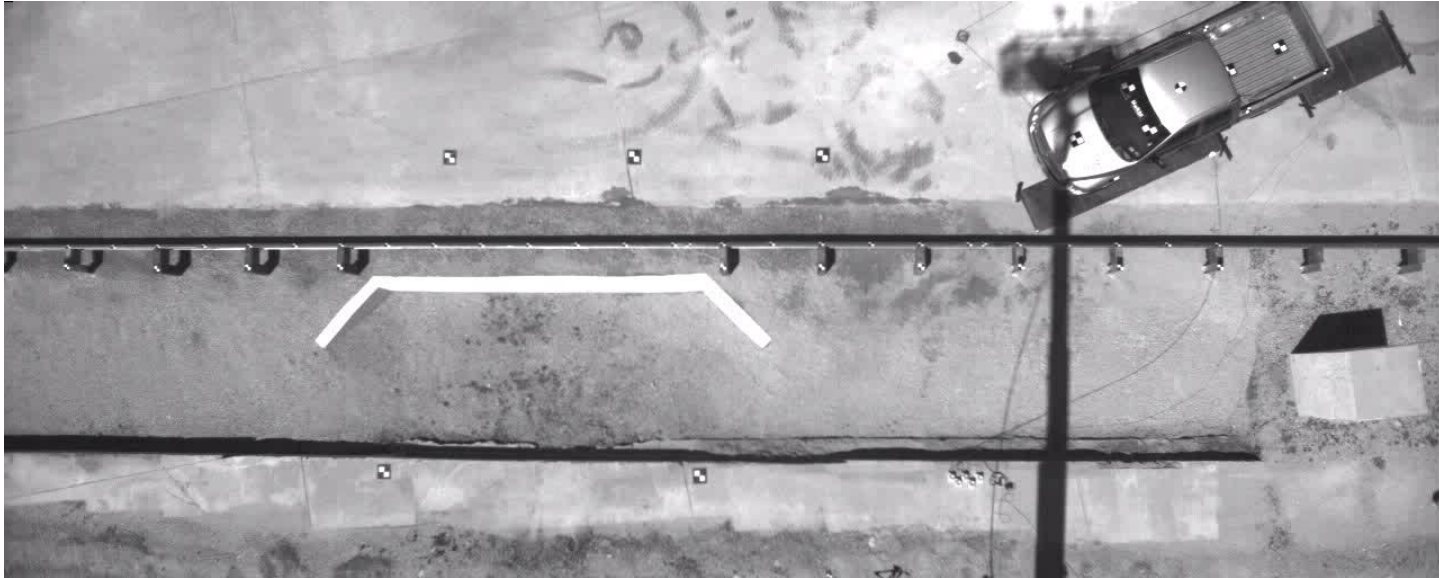
Test No. LSC-2

- 2,261-kg Dodge Quad Cab
- 99.6 km/h - 24.9 degrees

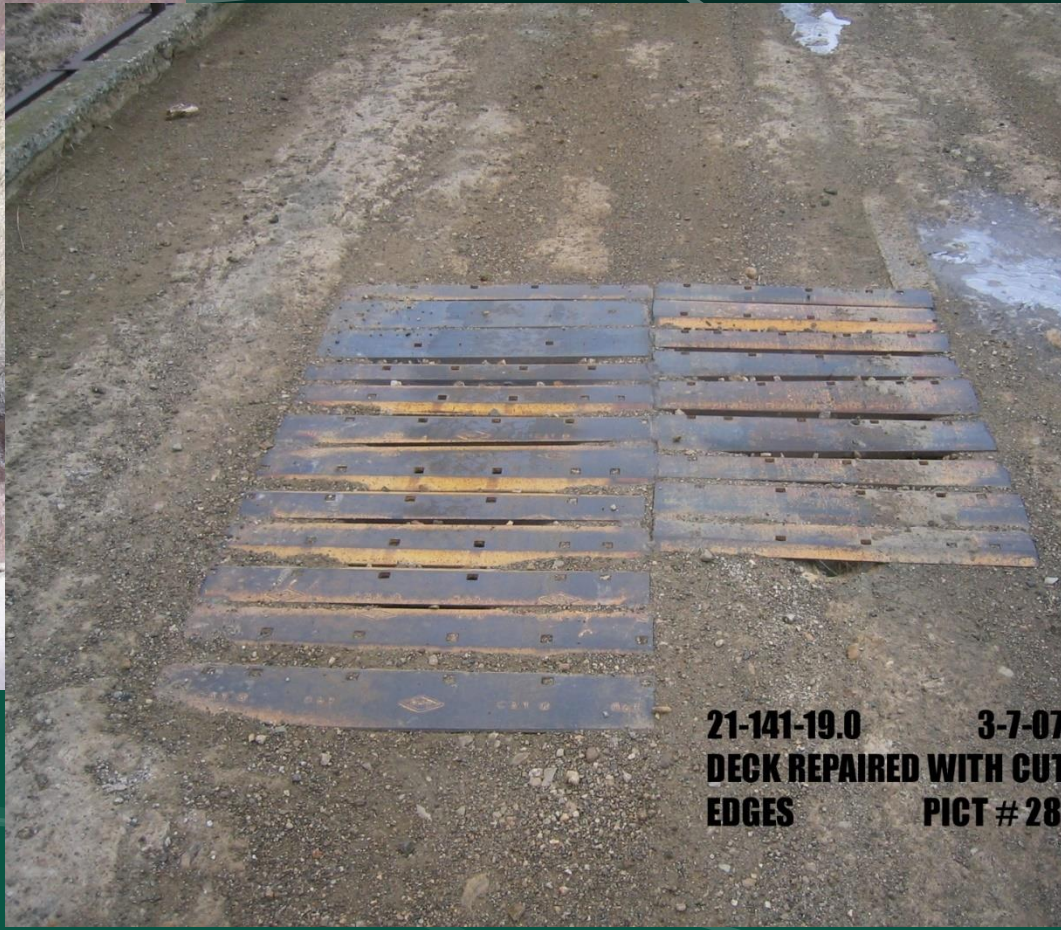
Bridge # 46-120-04.0
Direction: Up
Far North Deck Patch (2 in Deck)
02/15/05
